TECHNICAL NOTE No. 842

TIDEWATER AND WEATHER-EXPOSURE TESTS ON METALS

USED IN AIRCRAFT - II

By Willard Hutchler and W. G. Galvin

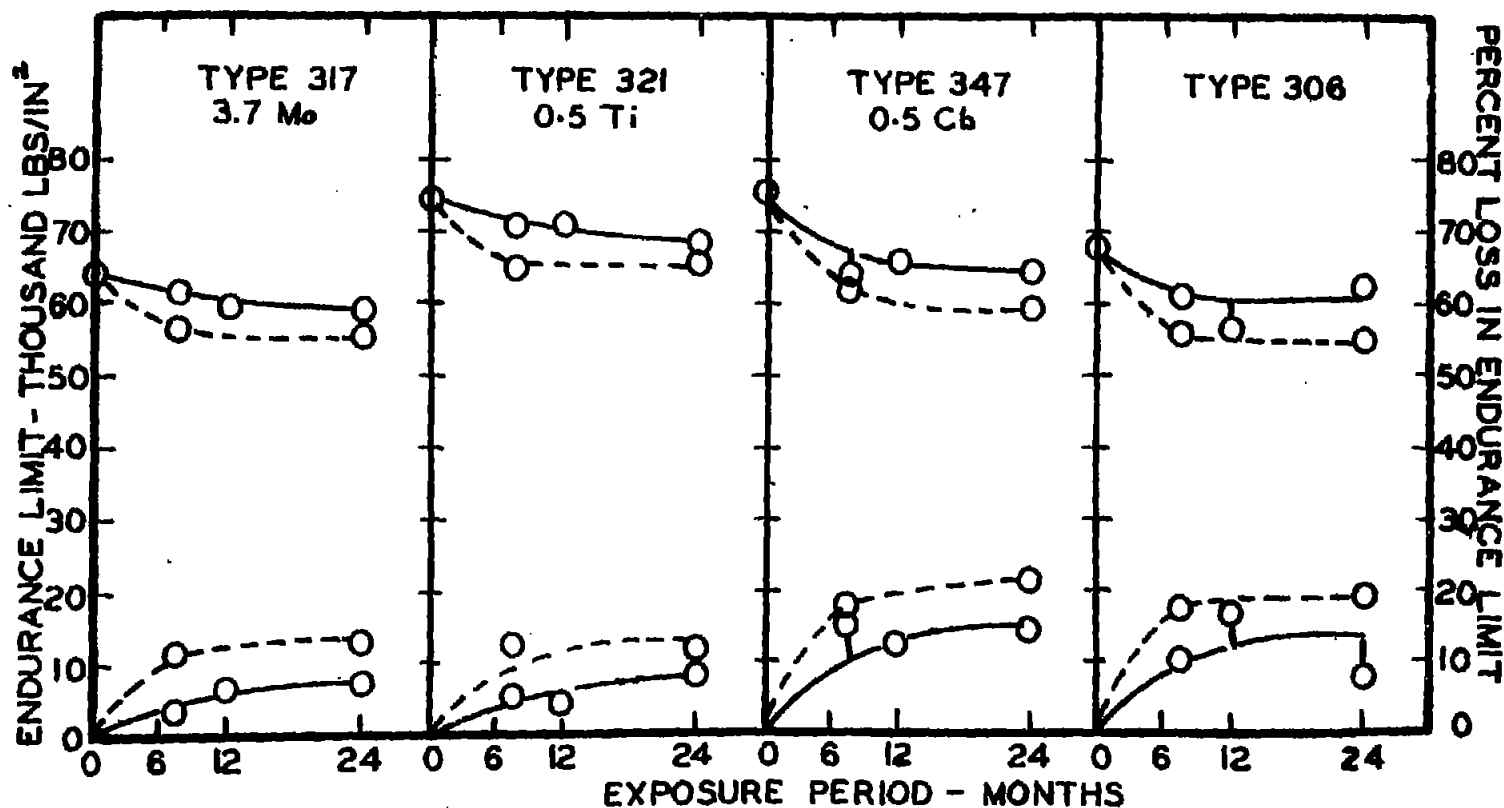
The endurance limits of some 300 specimens have been determined since reference 1 was released, both on panels as received (uncorroded) or on panels removed from the exposure racks during the first 2 years. The endurance limit values reported may be regarded as accurate only insofar as they serve to present a basis of comparison between the alloys tested. The values given (fig. 32 and table III) represent a stress, the half range of which was calculated to be within 800 pounds per square inch of the next highest stress, which resulted in fatigue failure, provided that at least two runs past 10^6 cycles had been made.

Figure 32.- Results of flexural fatigue tests on stainless steel. Solid line curves pertain to specimens exposed to tidewater; broken-line curves pertain to specimens exposed to the weather. The upper curves, in each instance, refer to values for endurance limits; the lower curves to percentage loss. Panels exposed to the weather consistently showed greater loss than those exposed to tidewater for equal periods. Steels containing molybdenum or titanium exhibited appreciably lower losses than those with columbium, or with no elements added to the typical 18 percent chromium, 8 percent nickel alloy (Type 306).
